FOUNTAIN CREEK REACH 7

AQUATIC RESTORATION PLAN NARRATIVE

Aquatic Assessment  
&  
Habitat Enhancement Plan  
Fountain Creek - Memorial and Mansions Park  
City of Manitou Springs  
El Paso County - Colorado

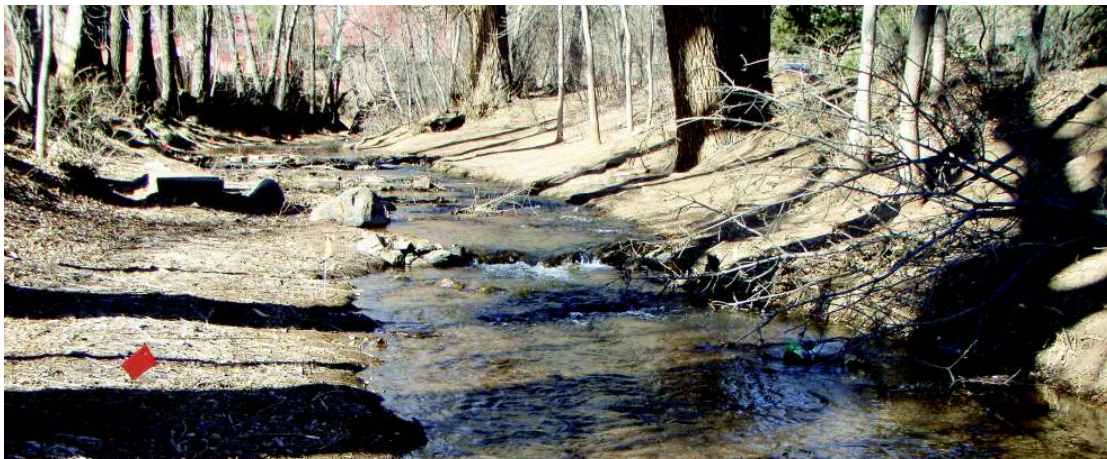
Photo 2: Cobble riffle in a B Channel within Reach 7 of Fountain Creek

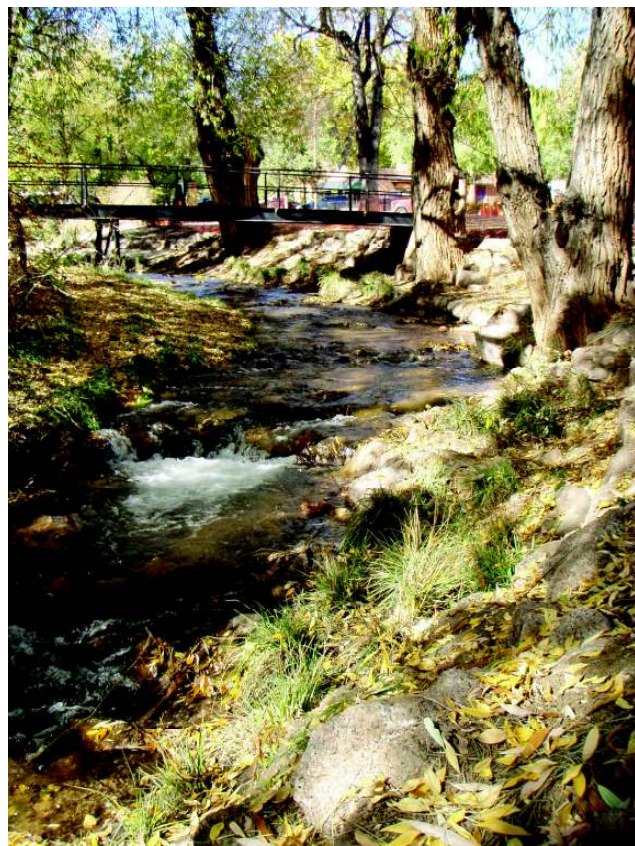
Photo 9: Restored stream bank and cross—vane. Soda Springs Park Reach 11 on Fountain Creek.

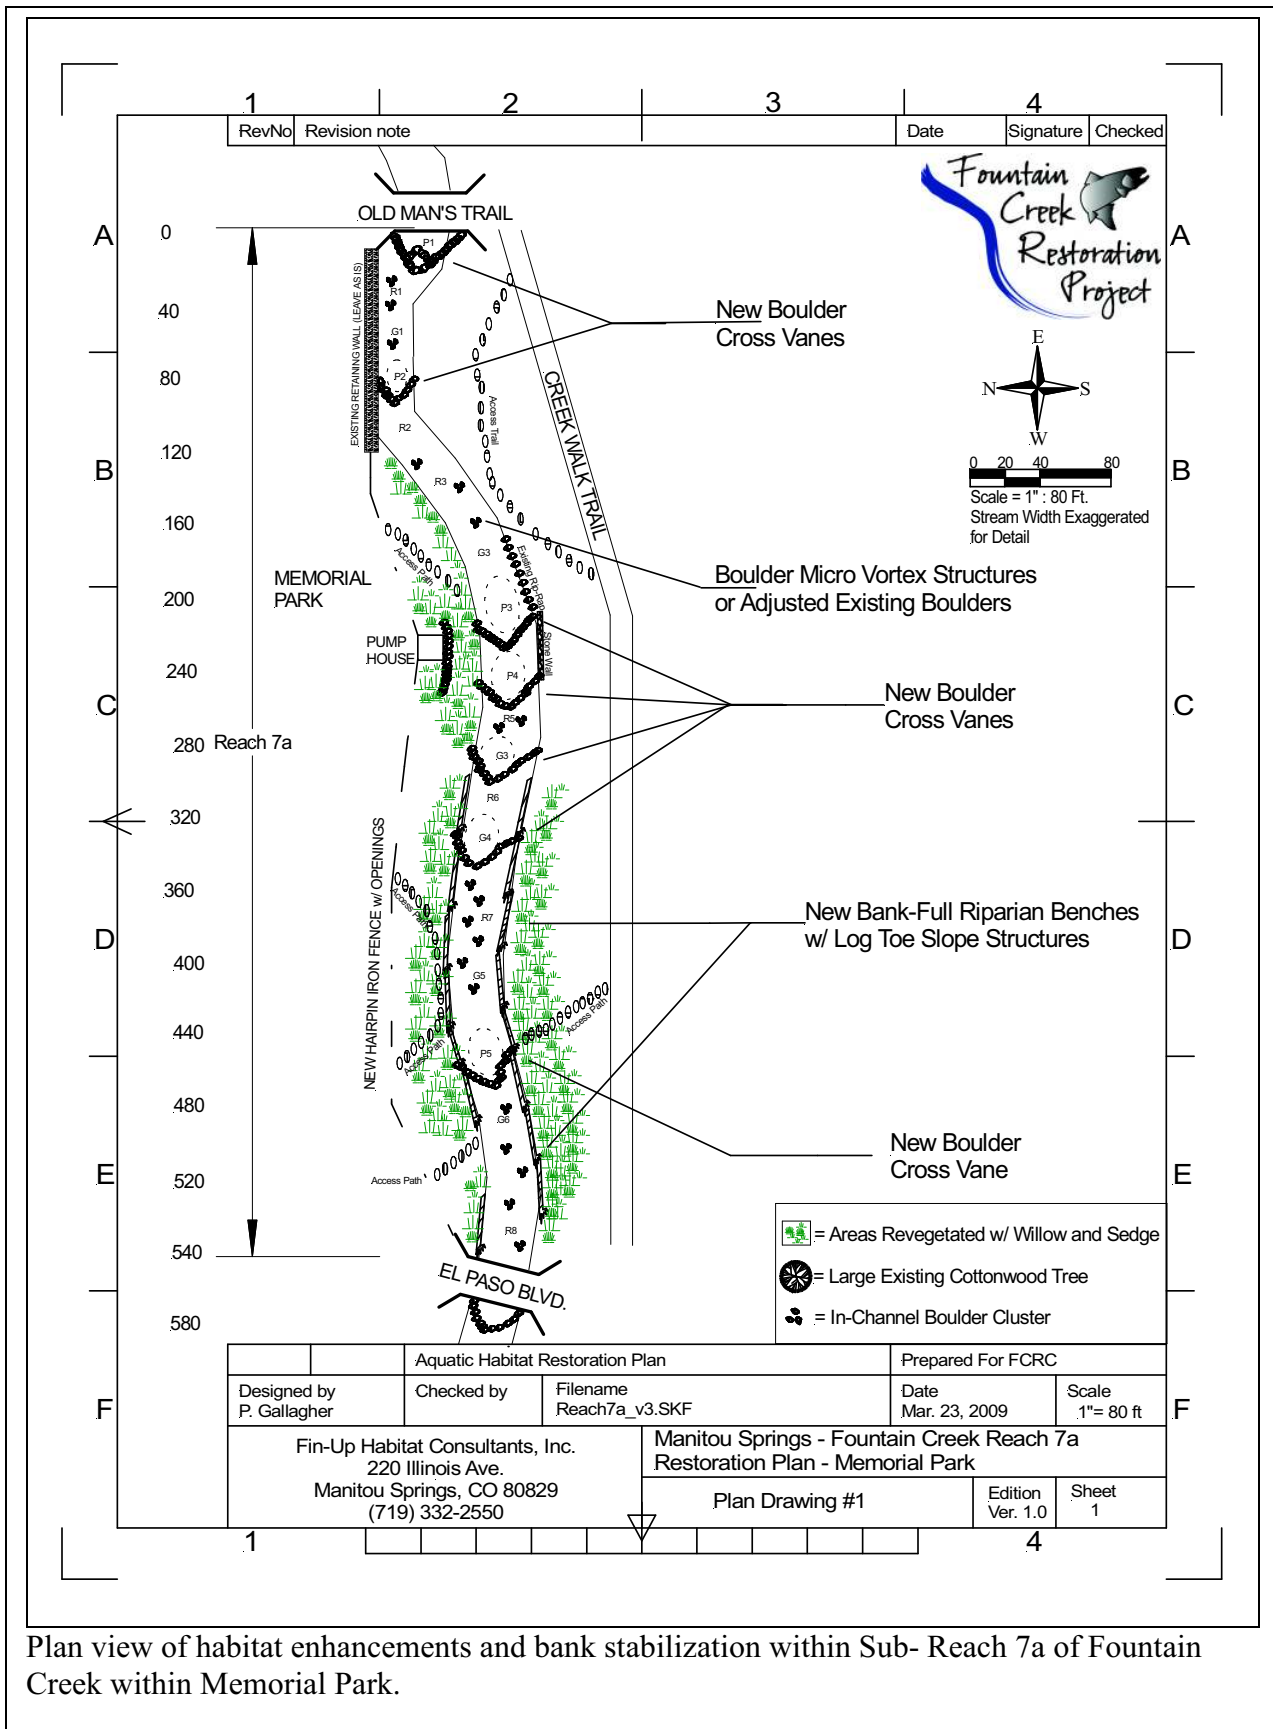
Plan view of habitat enhancements and bank stabilization within Sub- Reach 7a of Fountain Creek within Memorial Park.

A boulder cross-vane will be installed at the downstream boundary of the reach, enhancing the existing pool under the bridge at Old Man Trail. This cross vane will also provide enhanced vertical stability in the stream channel at this point, as well as protect the foundations of the historic stone bridge. Pocket water cover will be increased within Riffle 1 and Glide 1, using small rock cluster vortex structures. Pool 2 will be enhanced and expanded downstream into Glide 1 by constructing a boulder cross-vane near the top of this habitat, improving scour through the feature. Pocket water cover is currently adequate in Riffle 2, and will be increased in Riffle 3 by adjusting existing boulders in the riffle to provide better scour pockets downstream of these features. A cross-vane will be installed at Pool 3 to improve depth and extend the length of this habitat, and to reduce shear on the historic stone wall on the left side of the stream immediately upstream of this structure. Another cross-vane will be installed upstream at Pool 4 to further enhance this pool, as well as protect the pump-house perforated pipe buried on the right bank of the stream. This pipe is used to draw water from the stream for the purposes of irrigation of the park facilities, and currently requires continual maintenance due to being plugged up by fine sediment. A cross-vane will also be installed at the upstream limit of Glide 4, to covert this habitat to a functioning pool.

the left bank of Pool 3 will be re-aligned in order to provide velocity shelter for trout as well as bank armoring and protection from shear. The existing creek access trail on the left bank will be repaired, with stone steps leading down to Pool 3. Additionally, a new stone stairway will be constructed on the right bank leading to the stream, immediately downstream of the pump house.

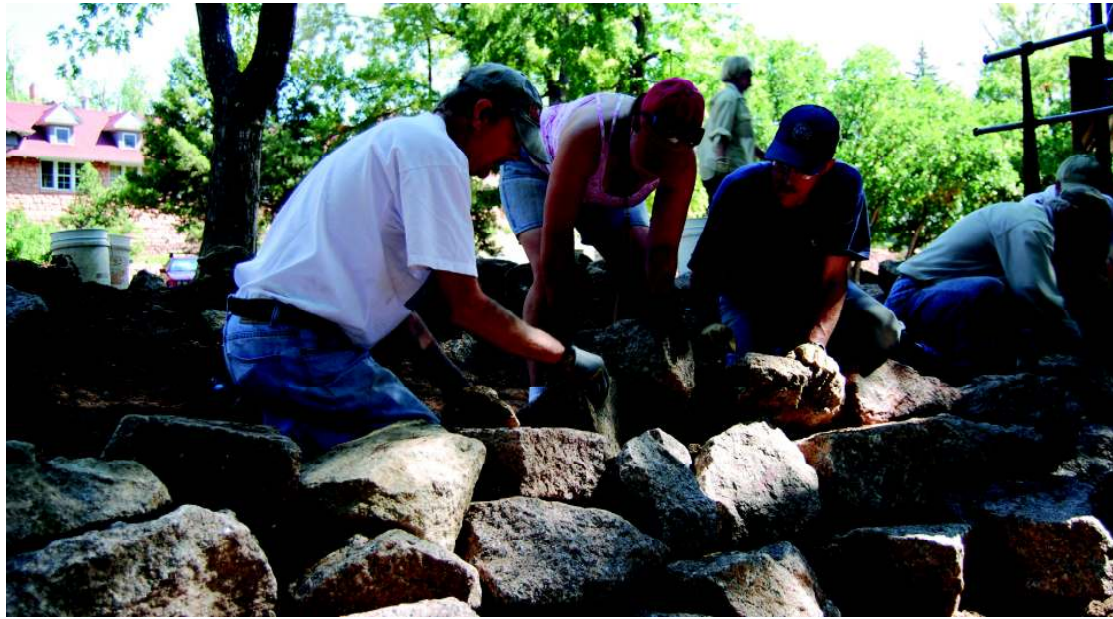
Photo 12: Volunteers constructing terrace walls for revegetation of stream banks. Similar techniques will be used in Sub Reach 7a to stabilize stream banks.

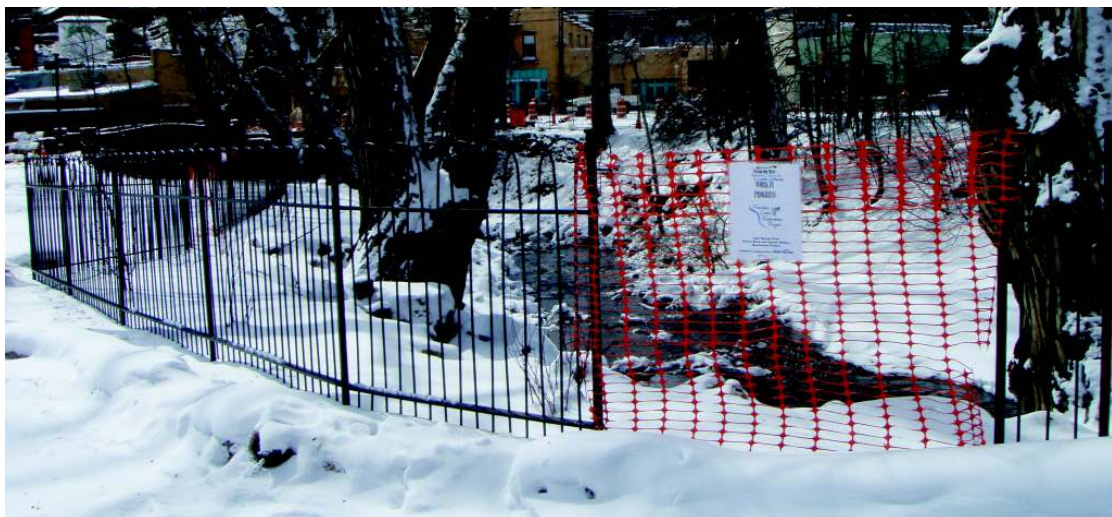
Photo 13: Iron hair-pin fence w/ path openings in Soda Springs Park (Reach 11)

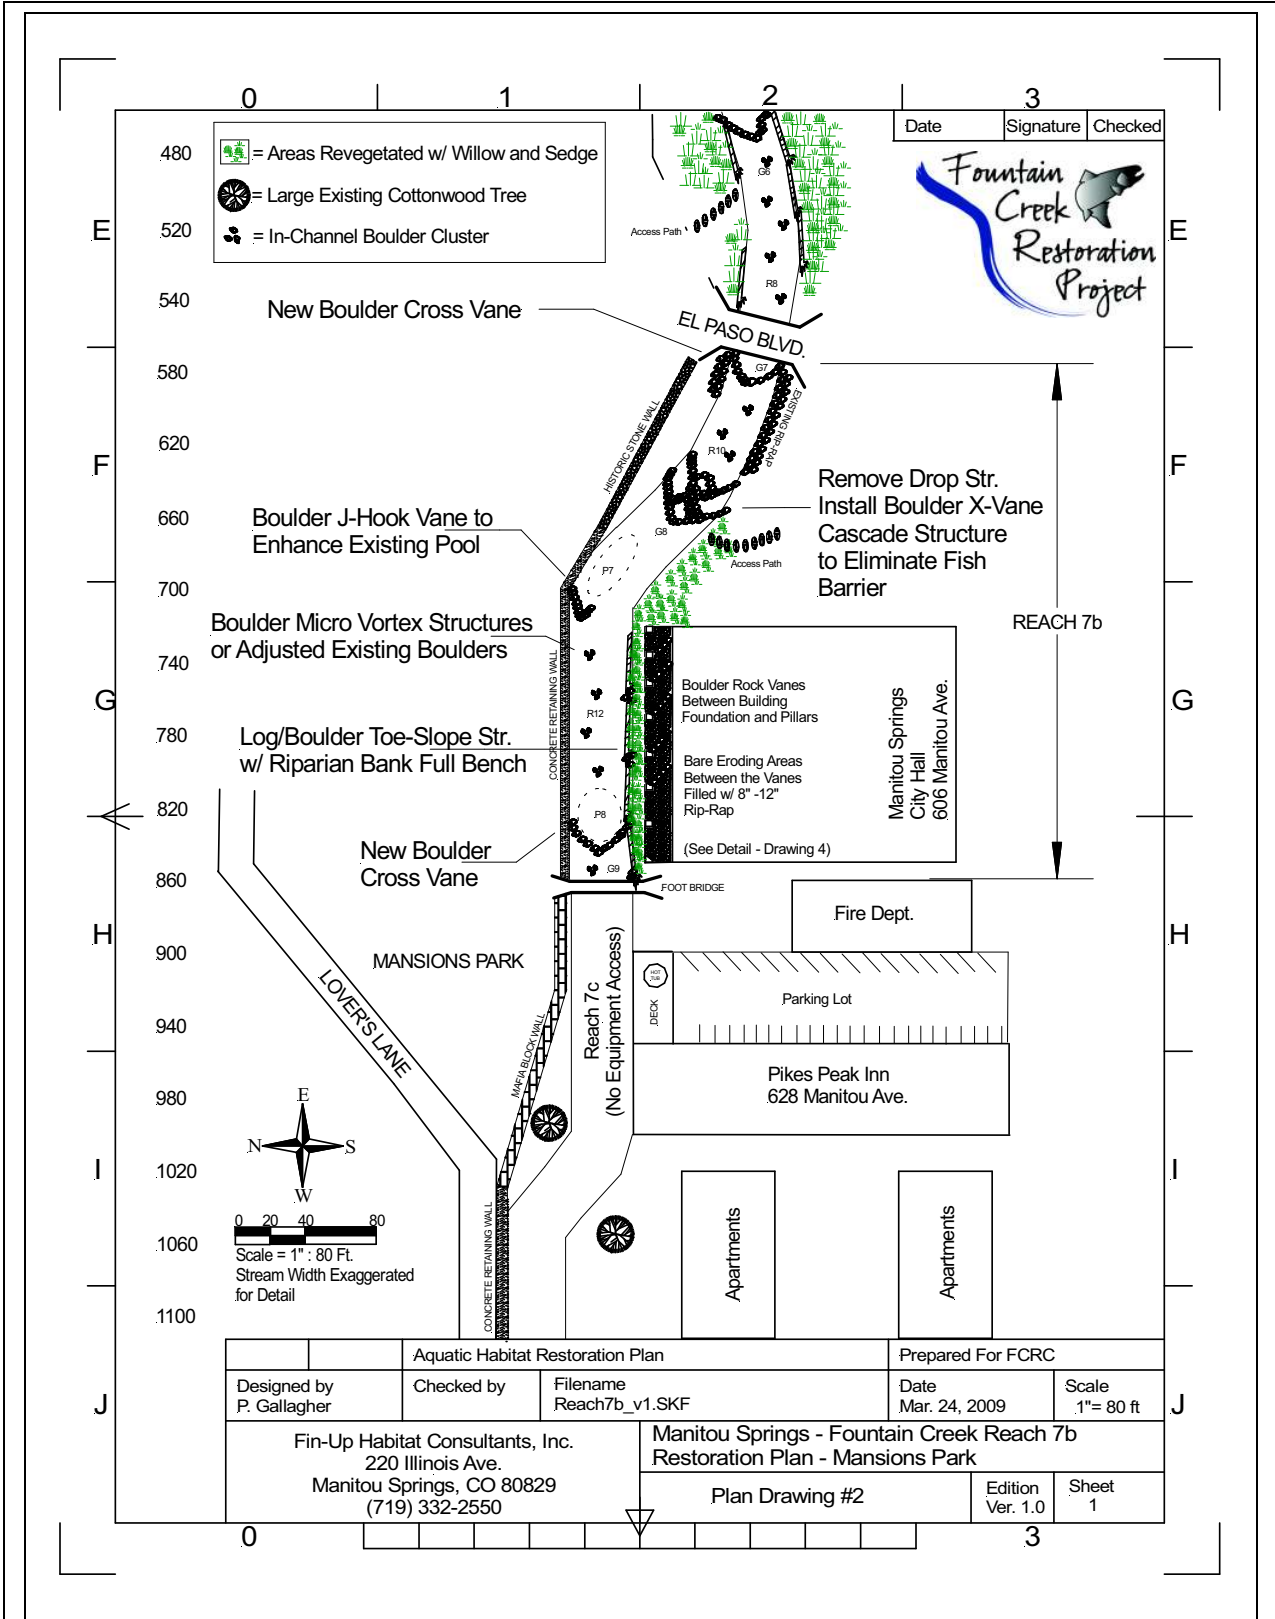
Plan view of habitat enhancements and bank stabilization within Sub- Reach 7b of Fountain Creek within Mansions Park.

A boulder cross-vane will be installed immediately upstream of the stone bridge at El Paso Boulevard. This cross vane will provide vertical stability in the stream channel and provide some protection the foundations of the historic stone bridge, while providing some additional pool habitat and fish viewing opportunities from the bridge. Pocket water cover will be increased within Riffle 9 & 10 by adjusting the elevation and aspect of existing boulders in these habitats. The center of the concrete “mafia block” drop structure and barrier at Riffle 11 will be removed, and replaced by a series of two boulder cross-vanes extending upstream into Glide 8 to create a step-pool cascade connecting the channel elevations between Pool 6 and Pool 7. The sections of the concrete drop structure that are embedded into the stream banks will be left in place, to provide bank stability at this point, but will be covered with top-soil and re-vegetated to camouflage these features. Pool 7 will be enhanced and expanded by constructing a boulder J-Hook vane near the top of this habitat, improving scour through the feature. A single access path, leading from the City Hall visitors parking area to Pool 7 will be constructed by volunteer crews.

willow has become established between the creek and the edge of the building, and we would like to further enhance this protective feature by installing log/boulder toe slope structures and riparian bank full benches along the entire south stream bank adjacent to the building. Behind these bank full bench features, boulder vanes may be installed underneath the building, extending at an angle of no greater than 30 degrees, from the foundation wall upstream to the concrete columns supporting the outer edge of the building. The spaces between these vanes could then be filled with smaller 8" – 12" rip-rap by the volunteer hand crews organized by the Rocky Mountain Field Institute.

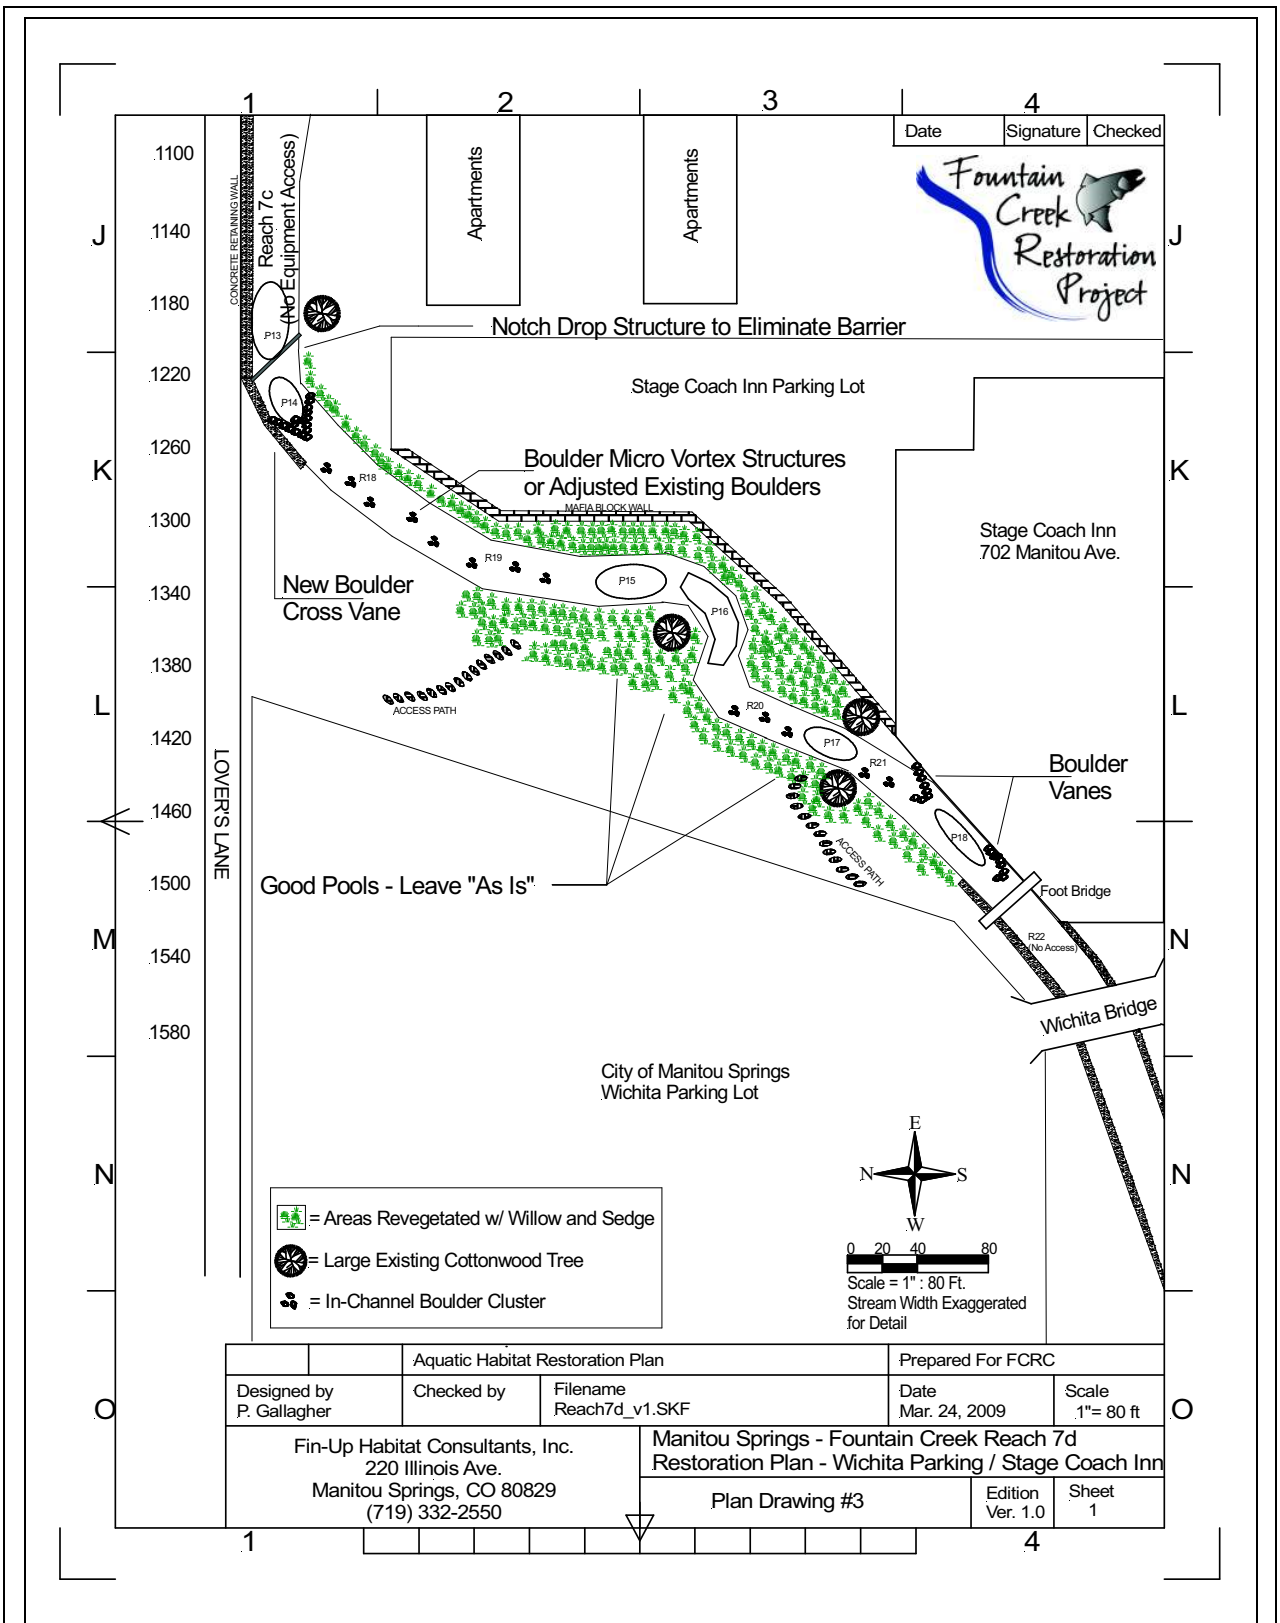
Plan view of habitat enhancements and bank stabilization within Sub- Reach 7d of Fountain Creek within Mansions Park.

Pocket water cover in Riffles 19, 20 and 21 will be increased and enhanced using the same techniques employed downstream; adjusting existing boulders as necessary and installing up to ten boulder micro-vortex structures. Two boulder rock vanes will be installed along the foundation wall of the Stage Coach Inn, where a lateral scour pool has begun to form immediately adjacent to the foundation footings. These boulder vanes will reduce shear forces along the foundation wall during high flows, as well as provide velocity shelter and fish viewing opportunities for guests dining on the deck of the restaurant immediately above this pool.

While the stream banks are mostly in relatively good condition in this segment, bare and eroded areas adjacent to the right stream bank, below the Wichita Parking Area, will be re-vegetated by RMFI work crews using transplanted sedge along the stream green-line, and native upland grasses and forbs on the slopes leading up to the parking area. Up to two access paths to the stream, with stone steps, will be constructed to allow public access to the stream along this segment.
